## Concorde's Crash in Paris 25<sup>th</sup> July 2000

### The Dream that ended for Air France as well as British Airways John Cook looks back at the Concorde's Crash

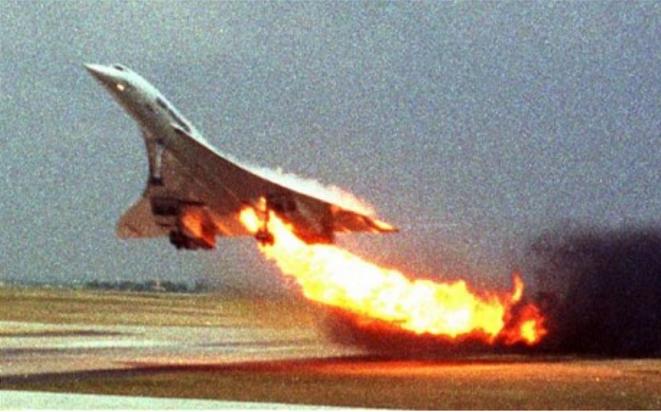
The famous photograph taken at the moment Concorde burst into flames, was taken aboard the Boeing 747 Airliner which had just landed from Japan and was waiting to cross the Concorde runway to gain access to the terminal. On that aircraft were Mr and Mrs Jacques Chirac, the President and First Lady of France.
